CONDITION AND VALUATION SURVEY REPORT

Name of Vessel:	JMC 50
Vessel Type:	Barge
IMO/ Registration No.:	Deck Barge
Job Number:	TSU-21-0102
Purpose:	Owner's Request
Place of Inspection:	Chaguaramas, Trinidad
Date of Inspection:	29 th May 2021
Inspector:	C. Lange

Vessel Type: Deck barge with bin walls
Flag: United States of America
Port of Registry: Amelia, Louisiana
Official#: 1069223
Length: 211.20ft
Breadth: 60ft
Depth: 14ft
Gross Tonnage: 1366
Hull Material: Steel
Year of Build: 1998
Builder: Corn Island Shipyard, Inc
Hull #: 144
Owner: Cashman Equipment Corporation
Construction Classification: ABS *A1

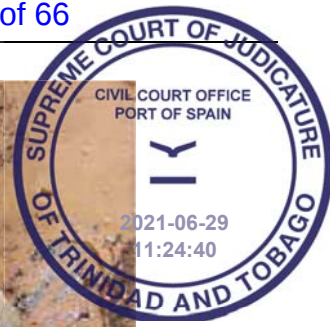
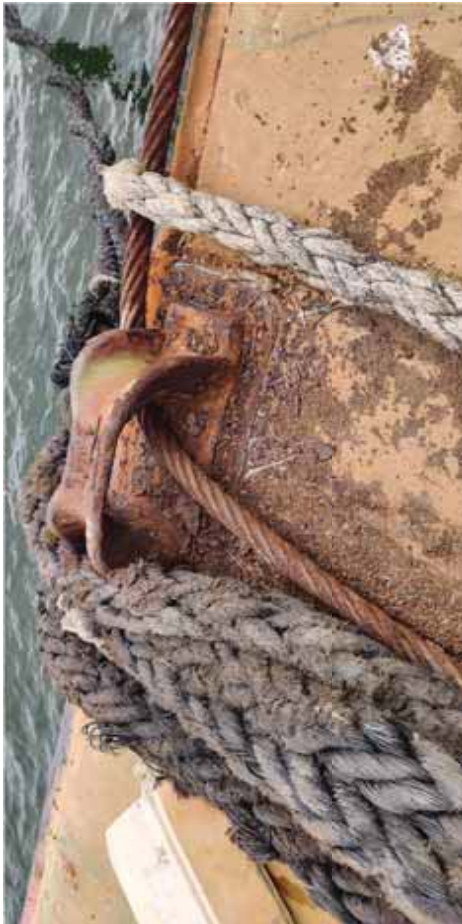
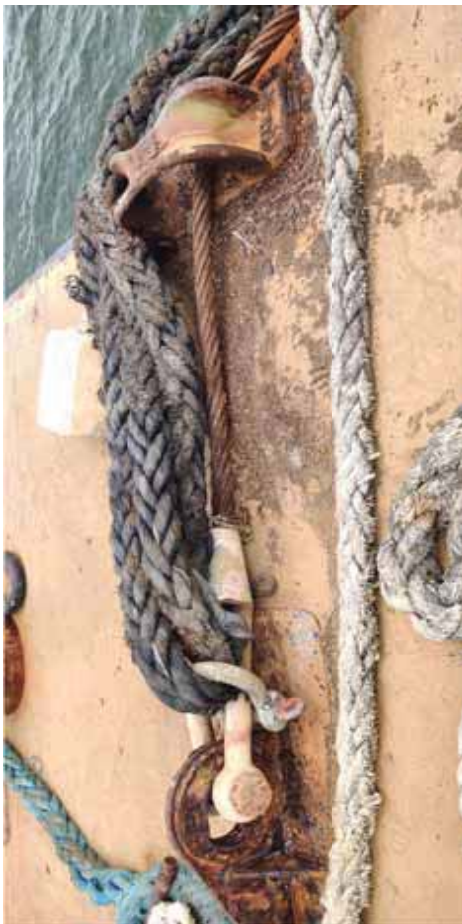
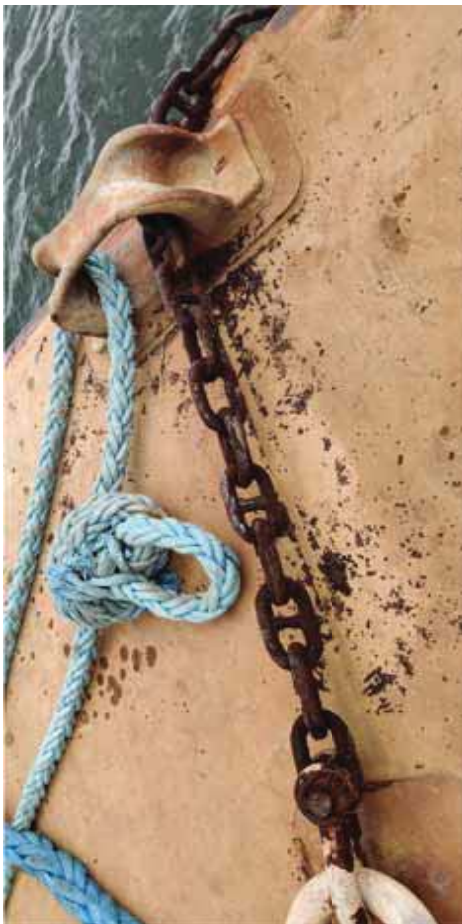
ANNEX 2

The towing arrangement consisted of padeyes located on port and starboard at bow with adjacent closed chocks and a 55T shackle with thirteen (13) links of 2" diameter stud link chain connected to each towing padeye. The towing pad eyes were severely corroded and port padeye distorted. The visible chain links of both bridle chains were also severely corroded including the joining shackle pin and several center studs were missing from the chain links on deck. However, both bridle fairleads were partly corroded but in satisfactory condition. The centreline padeye was fitted with a 55T shackle and a 2" diameter emergency tow wire threaded through the centerline fairlead and clipped along the starboard deck edge. The emergency towing wire was also moderately corroded and the lengths of towing bridle chains and tri-plate connection that have been submerged for more than 1 year and should be considered for replacement. **(See Annex 2 for photos)**

GENERAL CONDITION: Immediate maintenance required.

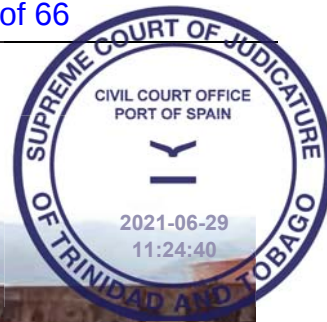
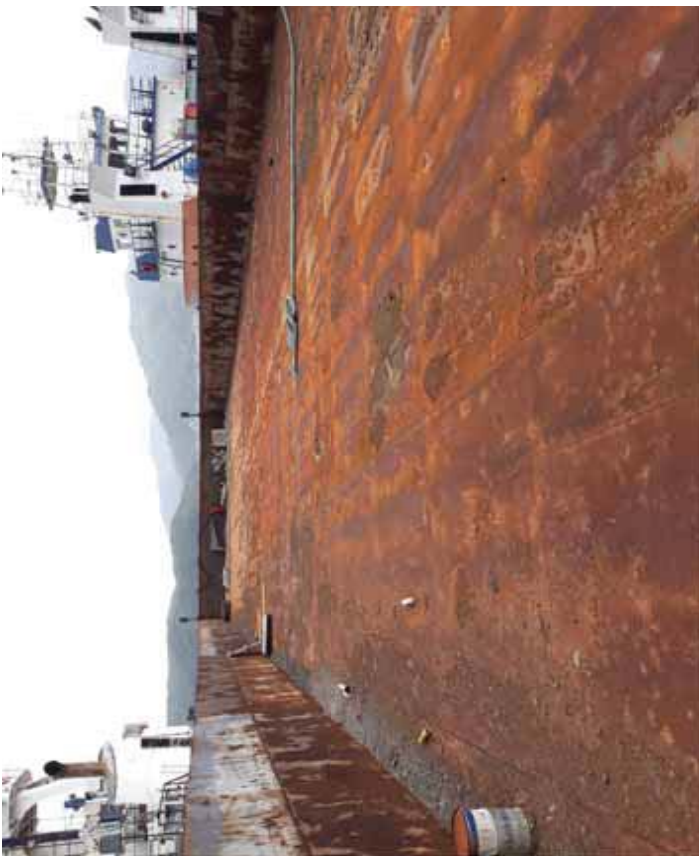
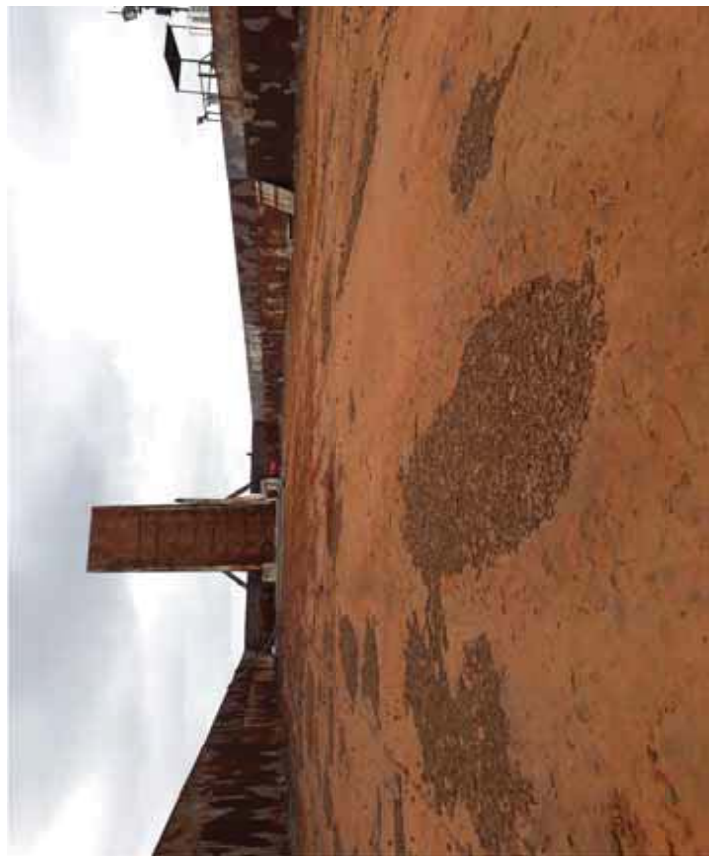
ANNEX 3

Inter-frame deformation was evident throughout the main deck with average deflection and wash boarding measuring 4cm. The main deck protective coating was non-existent and minor remnants of previous cargo evident. As a result of weathering and no apparent recent maintenance of all 8 strakes of plating, moderate surface corrosion was evident throughout and deck impressions of transverse bulkheads visible. The perimeter of the main deck was outfitted with a steel welded bin wall which was found mostly uncoated. Port and starboard bow navigation lights were outfitted forward on stanchions atop the bin wall however both stanchions were found with severe corrosion and wastage. A stern light stanchion was also provided on the starboard side of the aft ramp and anchor day shape on the fore deck. All navigation lights, screens and photo cell units were found in place.

GENERAL CONDITION: Fair

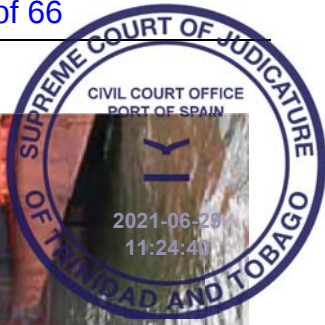
ANNEX 4

The external hull coating in these areas was estimated to be 60% depleted and found with no significant indents however, rust staining and minor corrosion was evident throughout. **(See Annex 4 for photos)**

GENERAL CONDITION: Fair

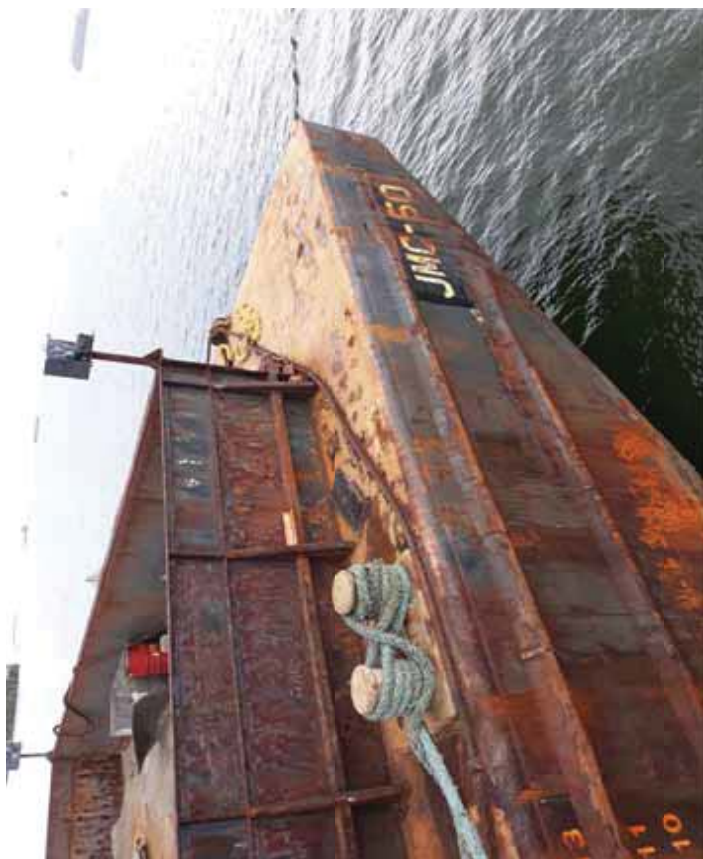
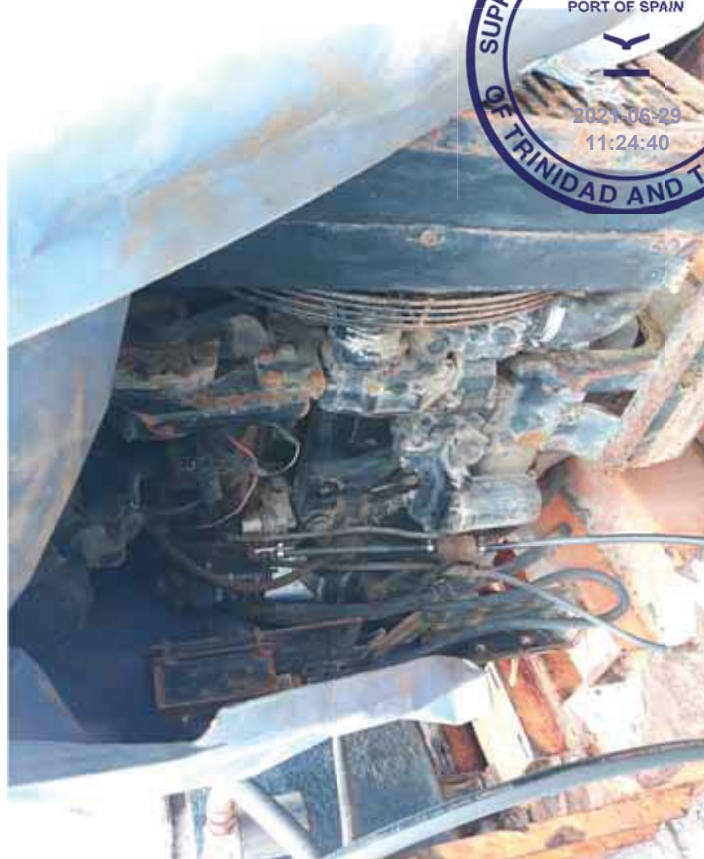
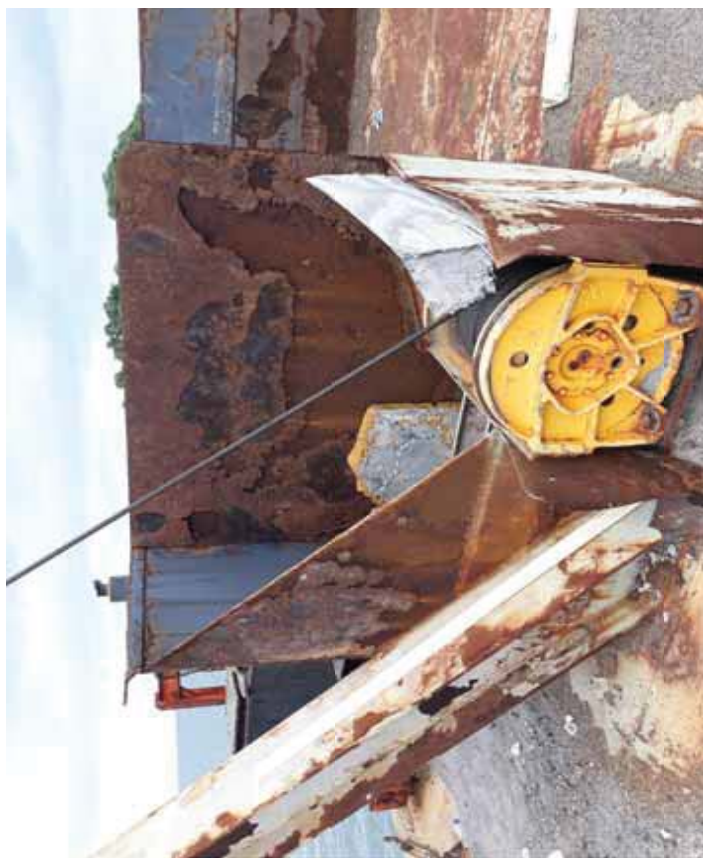
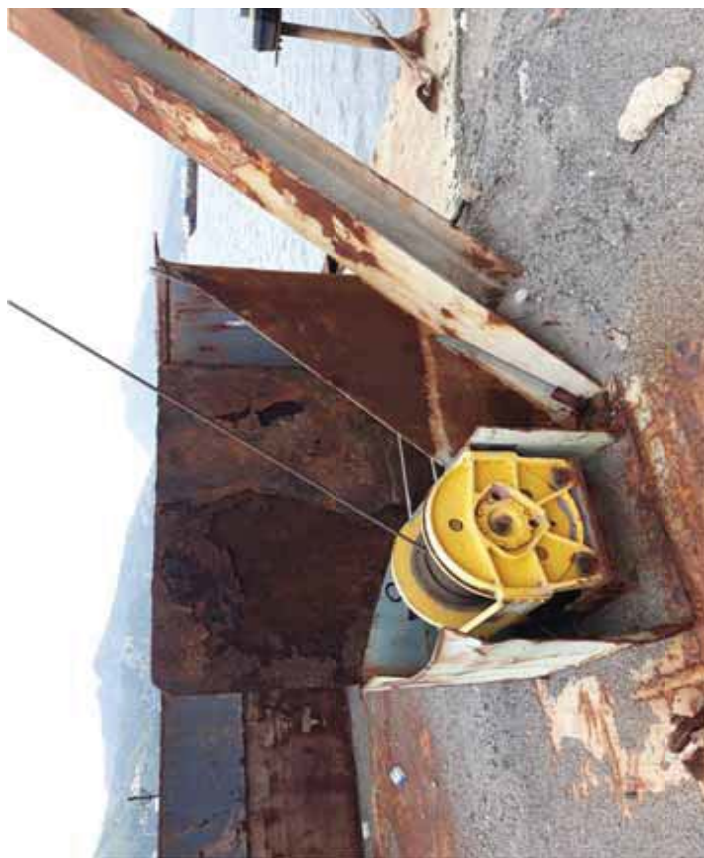
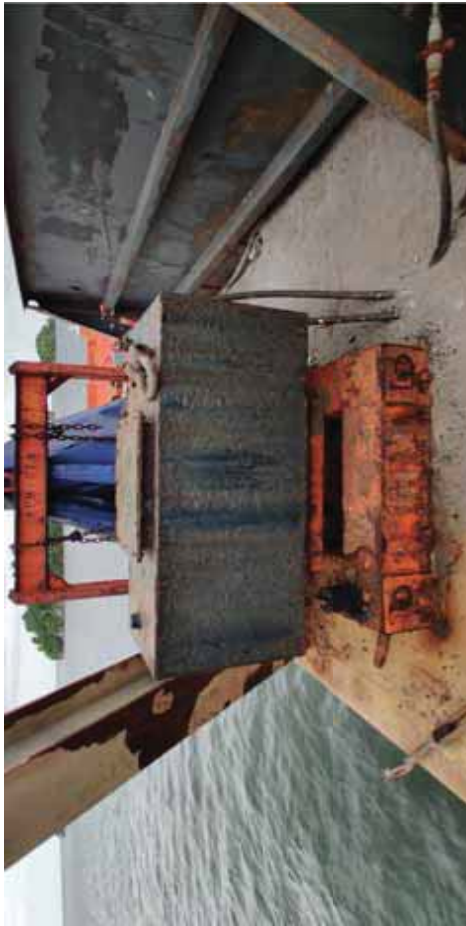
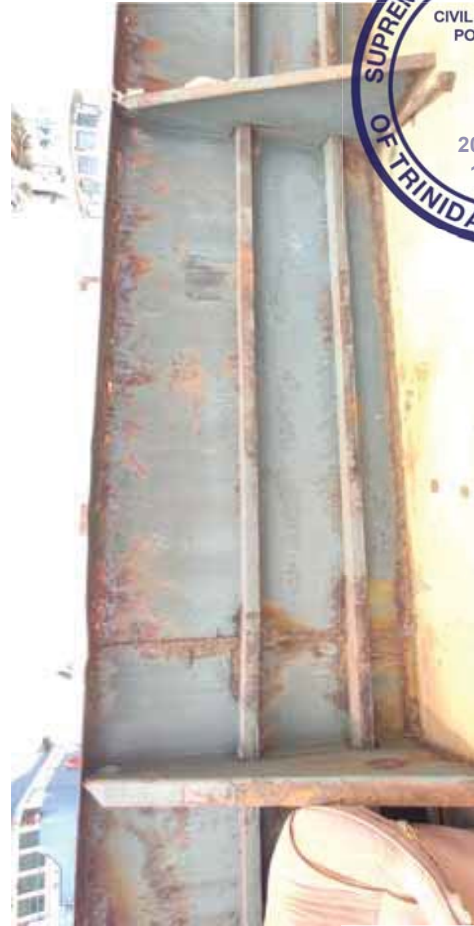
Forward and Aft Deck Photographs

These areas were located forward and aft of the bin walls. The protective coating was 50% depleted with minor corrosion evident but without deformation or wash boarding. The fore deck contained the anchor mooring rope, the tail of the emergency tow wire and towing bridle arrangements whereas the aft deck was outfitted with a hinged cargo access ramp, hydraulic tugger winches and a tank and engine mounted on a containment skid. The engine was considered to require general servicing however hydraulic fittings were in satisfactory condition. No obvious defects were observed on the stern ramp hinges and supporting Sampson posts however, all vehicle anti-skid arrangements on the ramp were damaged. A severe indentation approximately 1m in length with an indentation of depth greater than 5cm at mid span was observed on port side aft 3m forward of the mooring bollard.

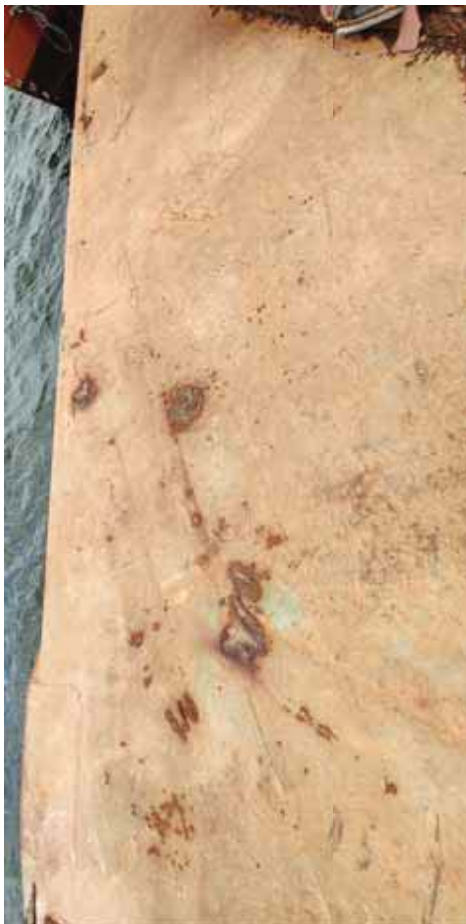
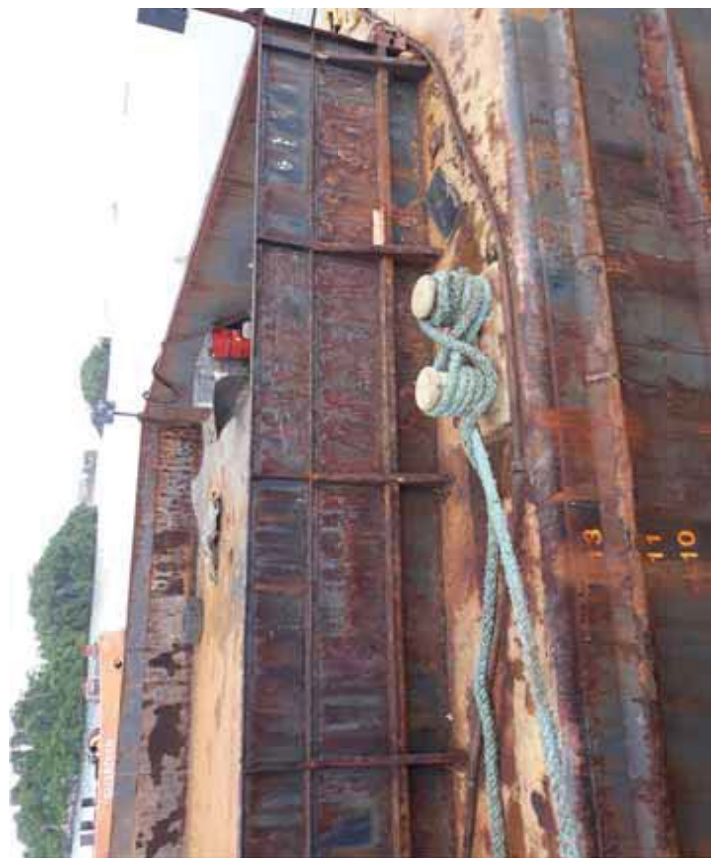
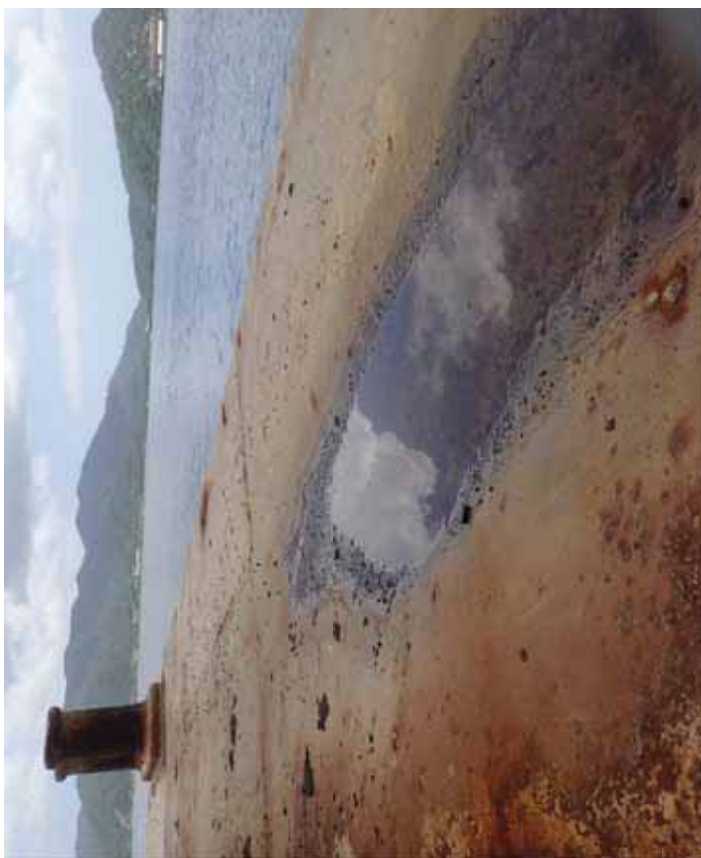
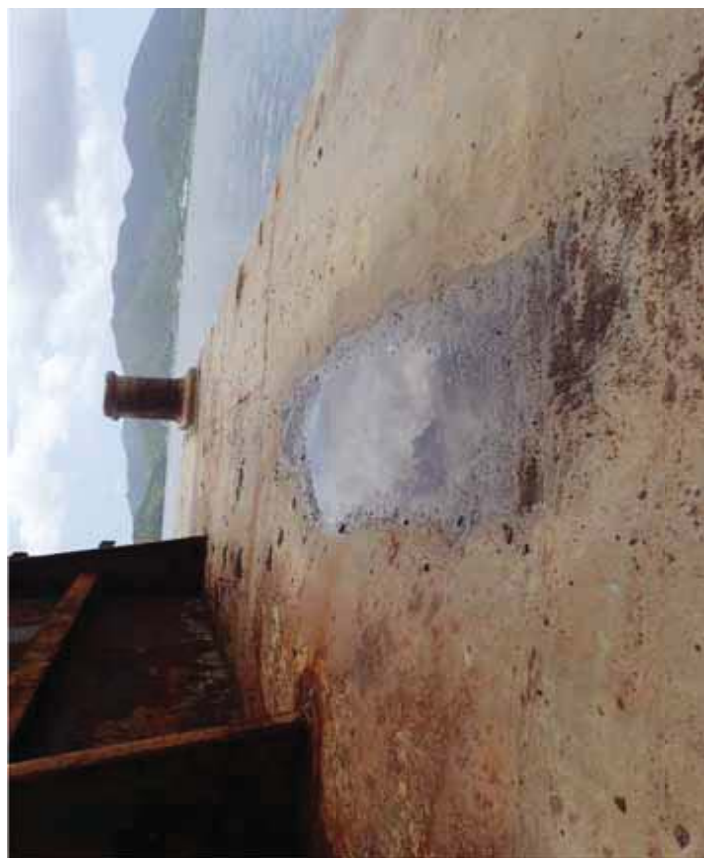
GENERAL CONDITION: Fair

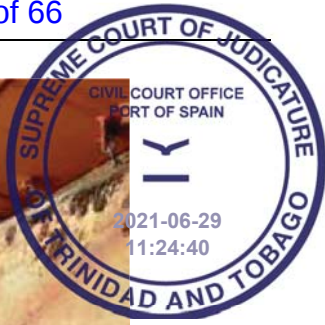
ANNEX 7

The vessel was not outfitted with anchors or an anchor windlass however, the towing bridle was attached by shackles onto bow pad eyes and bridle chains draped into the water via port and starboard bow fairleads. The barge was anchored using the towing bridle leading forward. Mooring bollards were outfitted on port and starboard bow shoulders and port and starboard aft quarters. All mooring bollards were found with moderate corrosion evident on foundations. Four sets of mooring cleats were provided equidistantly along port and starboard sides. All mooring cleats were also observed to have moderate corrosion evident.

GENERAL CONDITION: Fair

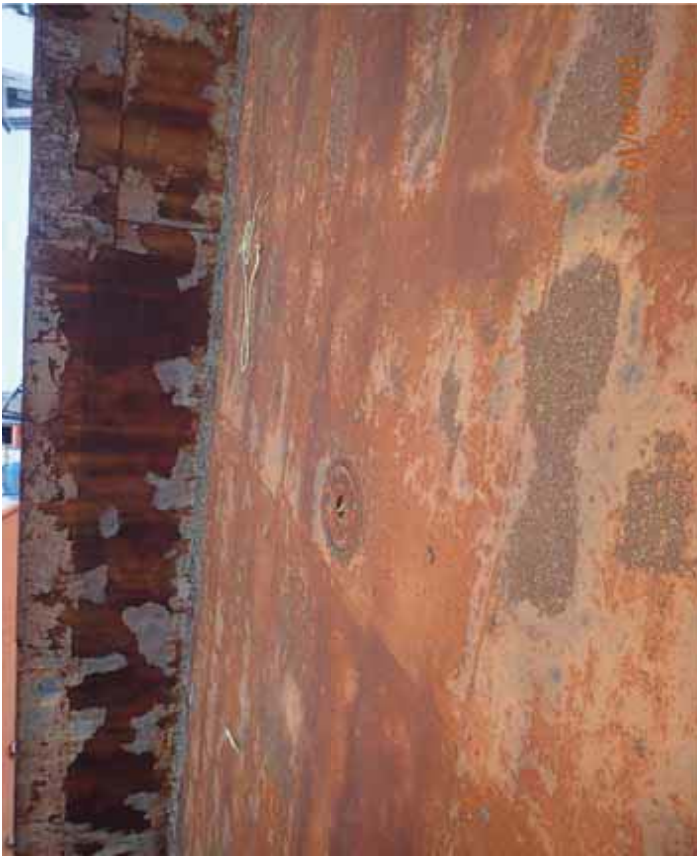
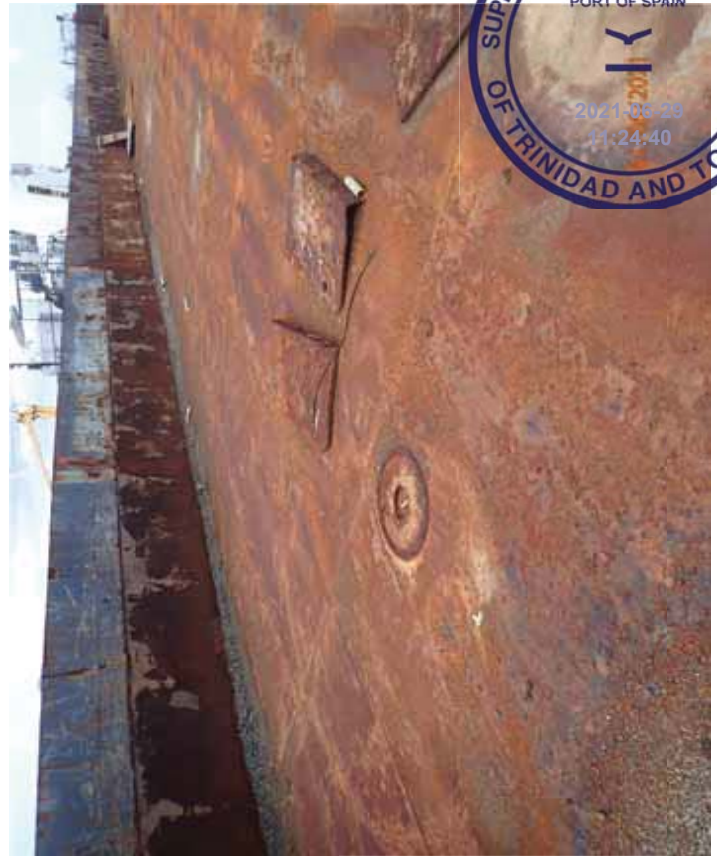
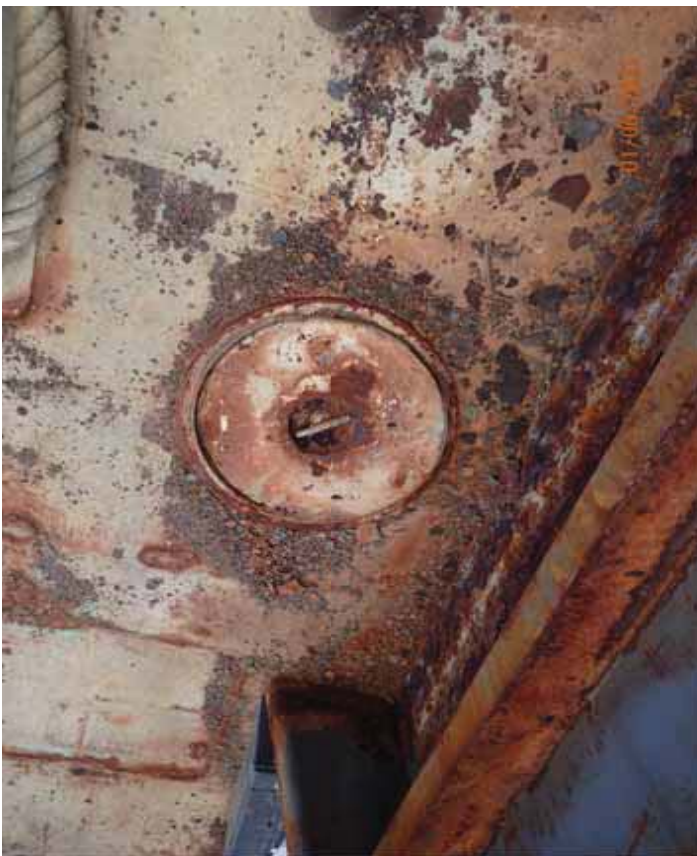
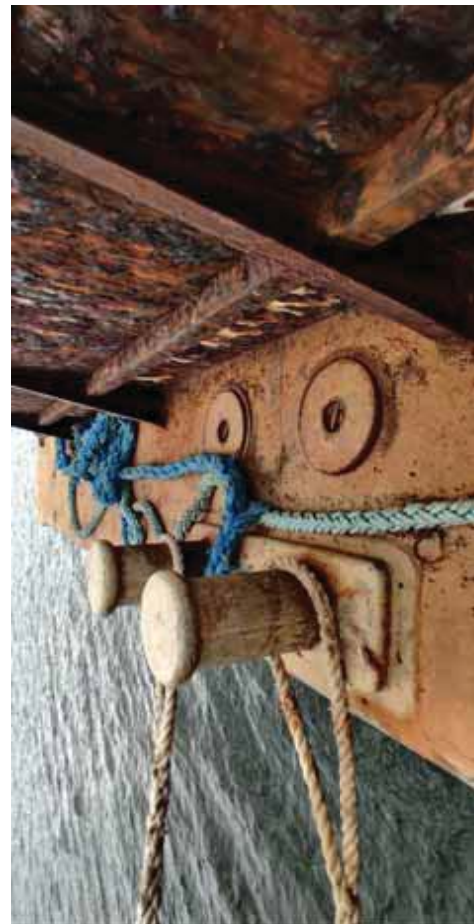
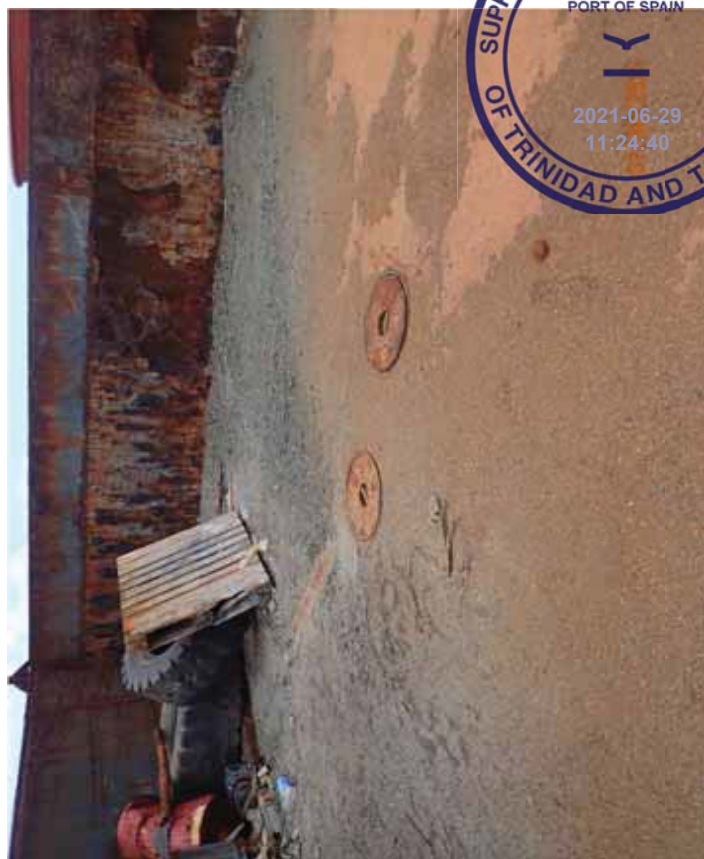
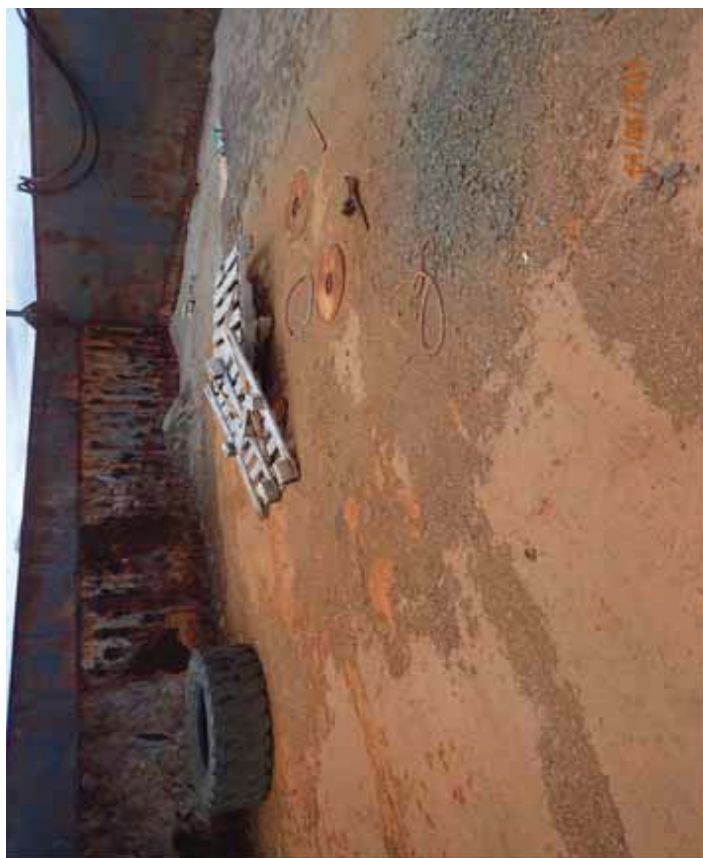
Manhole Covers Photographs

The vessel had manhole covers outfitted inboard and outboard of the cargo bin walls. No physical damages were noted for the hatches however, all sealing mechanisms were considered 50% degraded and with moderate corrosion evident. No tanks were opened and prepared for internal inspection at time of survey.

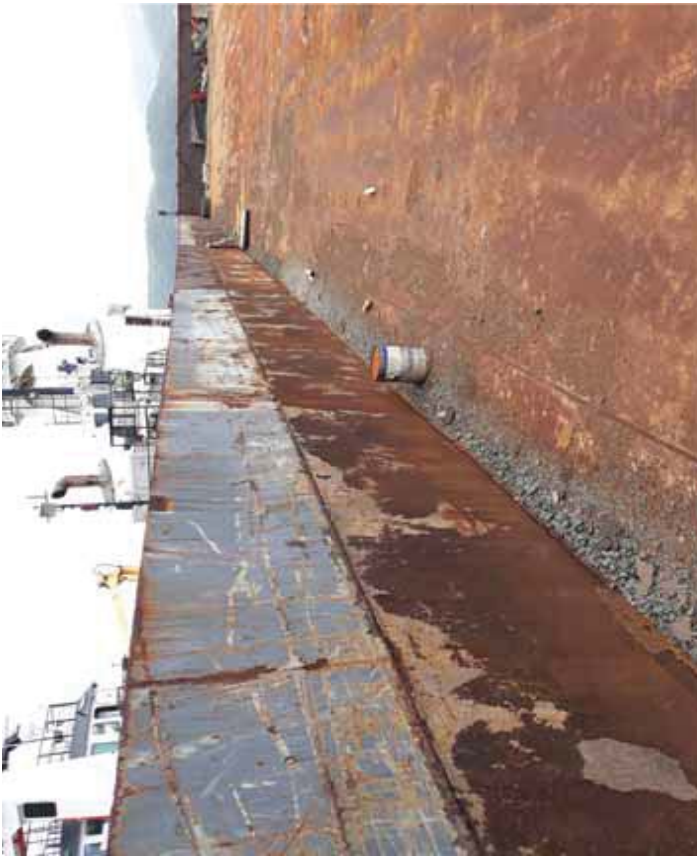
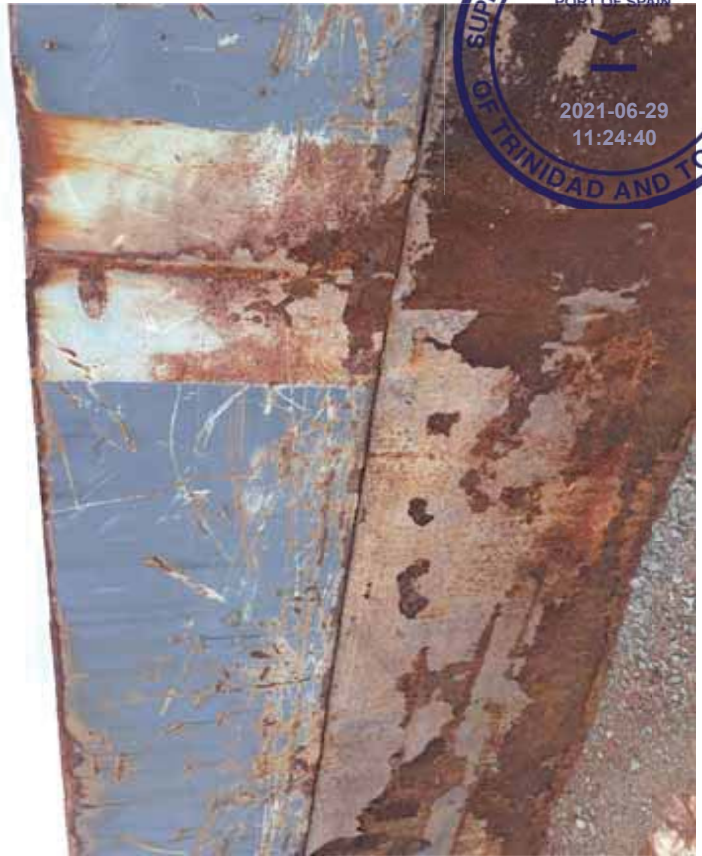
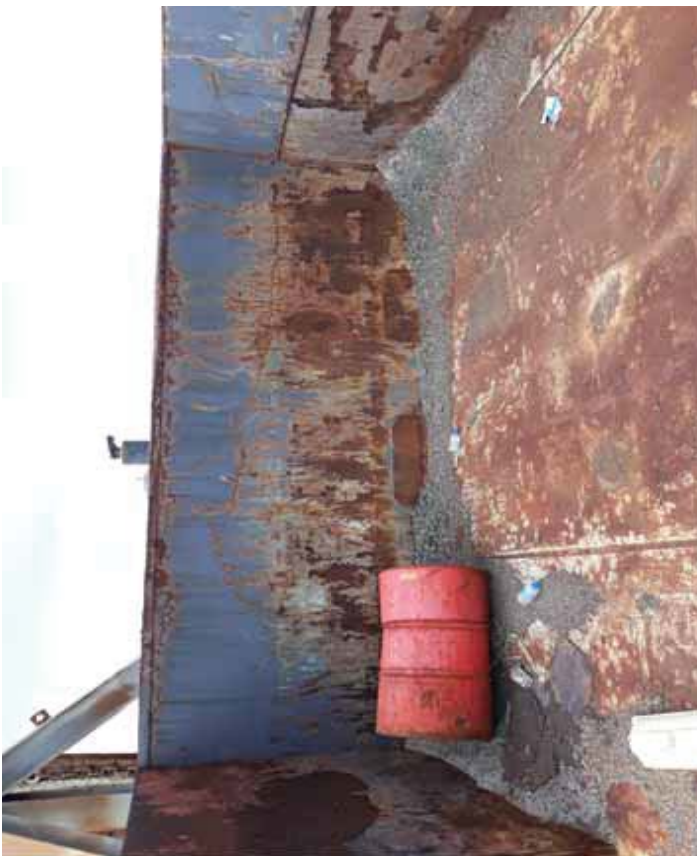
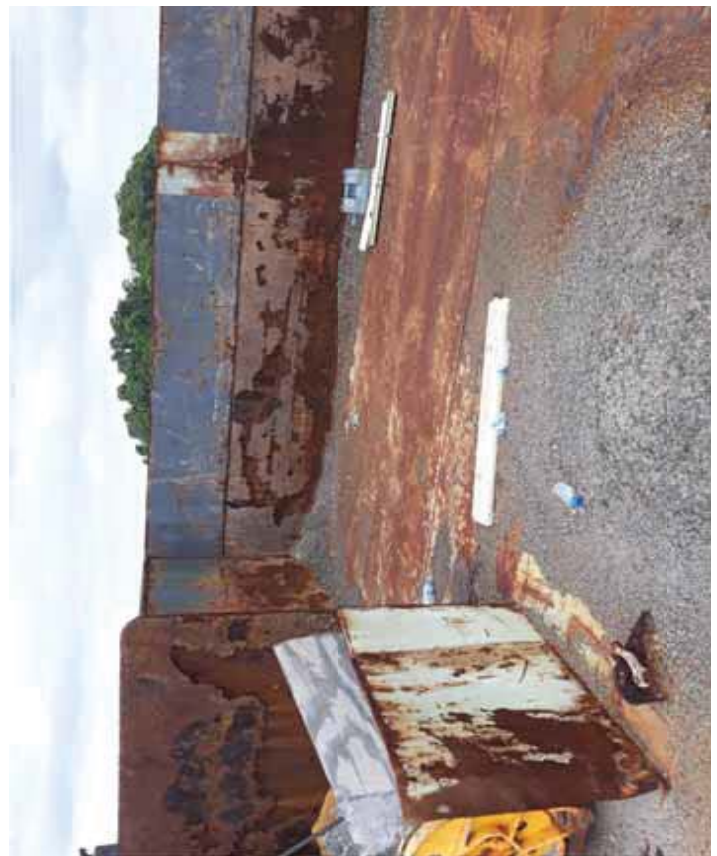
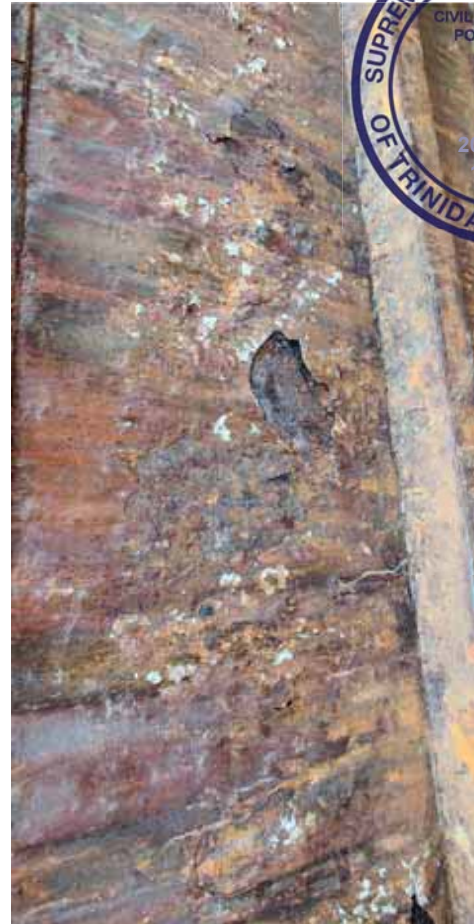
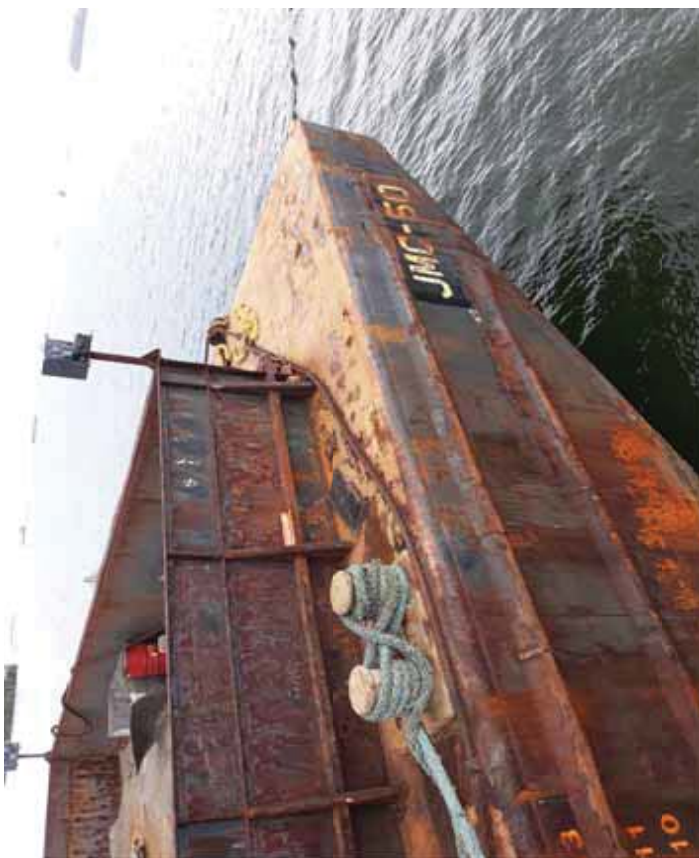
Bin Walls Photographs

The barge was outfitted with a 3m high bin wall extending throughout the vessel's perimeter approximately 2m inboard of the side shell with the only opening being in way of the aft cargo ramp. The bin wall consisted of two strakes of plating supported by outboard angular stanchions and mid span framing. The outboard side of the port and starboard bin walls were severely corroded with knife edge plating evident throughout however no holes due to wastage were noted. The inboard face of the port and starboard bin walls exhibited moderate corrosion on the lower strake of plating and 80% depletion of coating on the upper strake. A 5ft crack was found on bin wall plating on the port side 30ft from stern at mid height and a severe indentation due to overhead impact forward of amidships on the starboard side. (See Annex 9 for photos)
